New timber treatment requirements

Various activities are underway in the building industry in response to weathertightness problems and some steps have now been taken. One is the recent revision of the *Acceptable Solution for B2 Durability*. A key issue in this revision has been setting minimum levels of timber treatment for selected parts of a building through reference to the (also) revised standard NZS 3602. This feature discusses some important consequences of these revisions.

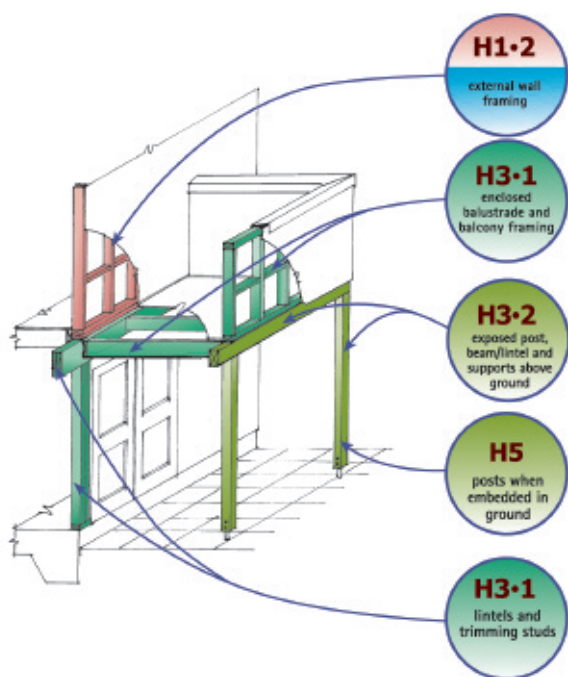
Figure 1: Enclosed balcony supported by posts and beams.

The problem with enclosed balconies is that they frequently leak and any leaks can travel into structural framing and may go unnoticed until structural failure occurs. The timber framing for deck joists and balustrades must be treated to H3.1. In addition, framing below decks or balconies must be treated to at least H1.2. Where a deck or balcony is supported by high-load critical elements enclosed by linings or claddings in an interior or exterior wall (such as beams or lintels over large openings), these will require treatment to a higher level than the rest of the wall. See Figure 1.

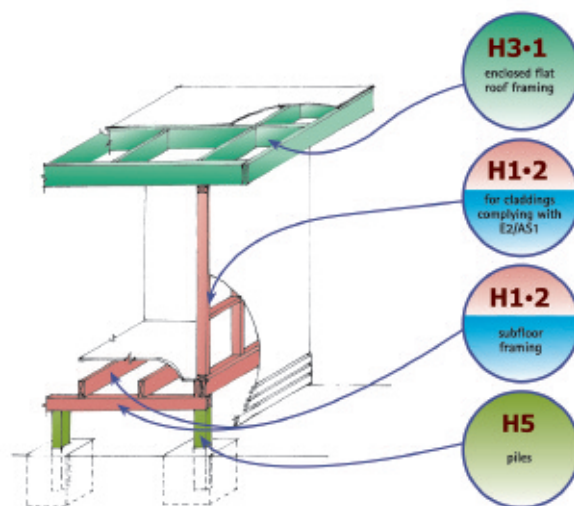
Figure 2: Low-slope roof framing for roofs 1.5°–10°.

Enclosed low-slope roof framing must have H3.1 treatment because if a leak develops there is no ventilation to aid drying. Rot could then develop, unobserved, with serious consequences. See Figure 2.
